Bagcilar Medical Bulletin 2017;2(3):71-74 DOI: 10.5350/BMB20170913031055

# Hydrogel Implant Causing Lumbar Radiculopathy: A Case Report

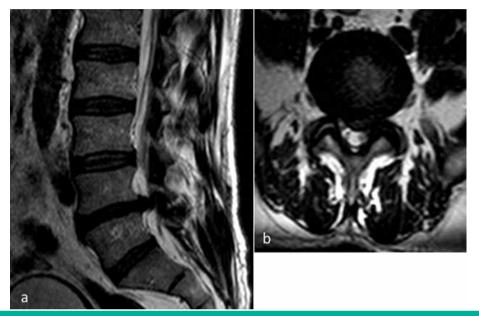
Figure 1: A left L4-5 lumbar disc herniation with a wide basis was seen on the T2-weighted sagittal (a) and axial (b) MRI sections before percutaneous hydrogel implantation.

A 61-year-old male was admitted to our outpatient clinic with complaints of low back and severe left leg pain. His history revealed that he had suffered from low back pain for 2 years and had been treated with a percutaneous hydrogel implantation into his degenerated L4-5 disc level (Figure 1) in the Pain Clinic at our hospital. A very severe left leg pain

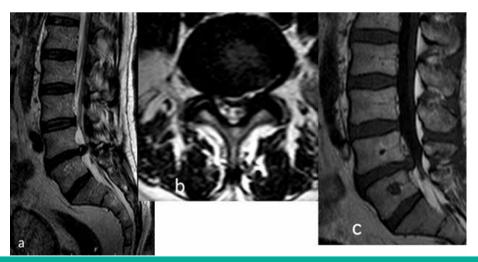
Figure 2: A lesion mimicking lumbar disc herniation and annular defect was seen on the T2-weighted sagittal (a), T2-weighted axial (b), and T1 weighted sagittal (c) MRI sections 6 months after percutaneous hydrogel implantation. It was noted that the lesion was hyperintense on T2-weighted and hypointense on T1-weighted MRI section.

Findings of his neurological examination were left straight leg raising test positivity at 30 degrees, paresis of left great toe dorsiflexion with 4/5 muscle strength, and hypoesthesia at the left L5 dermatome. Lumbar magnetic resonance imaging (MRI) revealed a lesion mimicking left L4-5 disc herniation. The lesion was hypointense on T1-weighted and hyperintense on T2-weighted MRI sections and it compressed the left L5 nerve root on the L4-5 disc space level (Figure 2).
